<u>SITE NUMBER</u> OBD01 - Rooiels		<u>LAUNCH SITE TYPE</u> Coastal slipway, public	
<u>LEGAL STATUS</u> Licensed Date of renewal: 19 February 2010 Agreement of Lease for slipway from 1 September 1996 Cape Nature File: 1/2/5/1/8/G257		<u>DATE OF INSPECTION</u> 7 February 2010	
<u>LOCATION</u> (description) Between Gordon's Bay and Pringle Bay. At The end of Bathers road in Rooiels.			
<u>LOCATION</u> GPS Coordinates: LHS RHS		34° 17.941' <u>S</u> 34° 17.940' <u>S</u>	18° 49.043' <u>E</u> 18° 49.047' <u>E</u>
<u>COMPETENT AUTHORITY</u> Department of Environmental Affairs and Development Planning.			
<u>MANAGEMENT AGENCY</u> Overstrand Municipality Neville Green (082 4124840)			
<u>RESPONSIBLE AUTHORITY</u> Rooiels Boat Club A.J. Wagener (028 273 8424 or 072 183 0812)			
<u>ACCESS CONTROL</u> There is a boom with poles attached to prevent people from carrying boats through. There is no person on duty or fees charged to launch however a permit from the boat club is required. No records of vessels launched are kept.

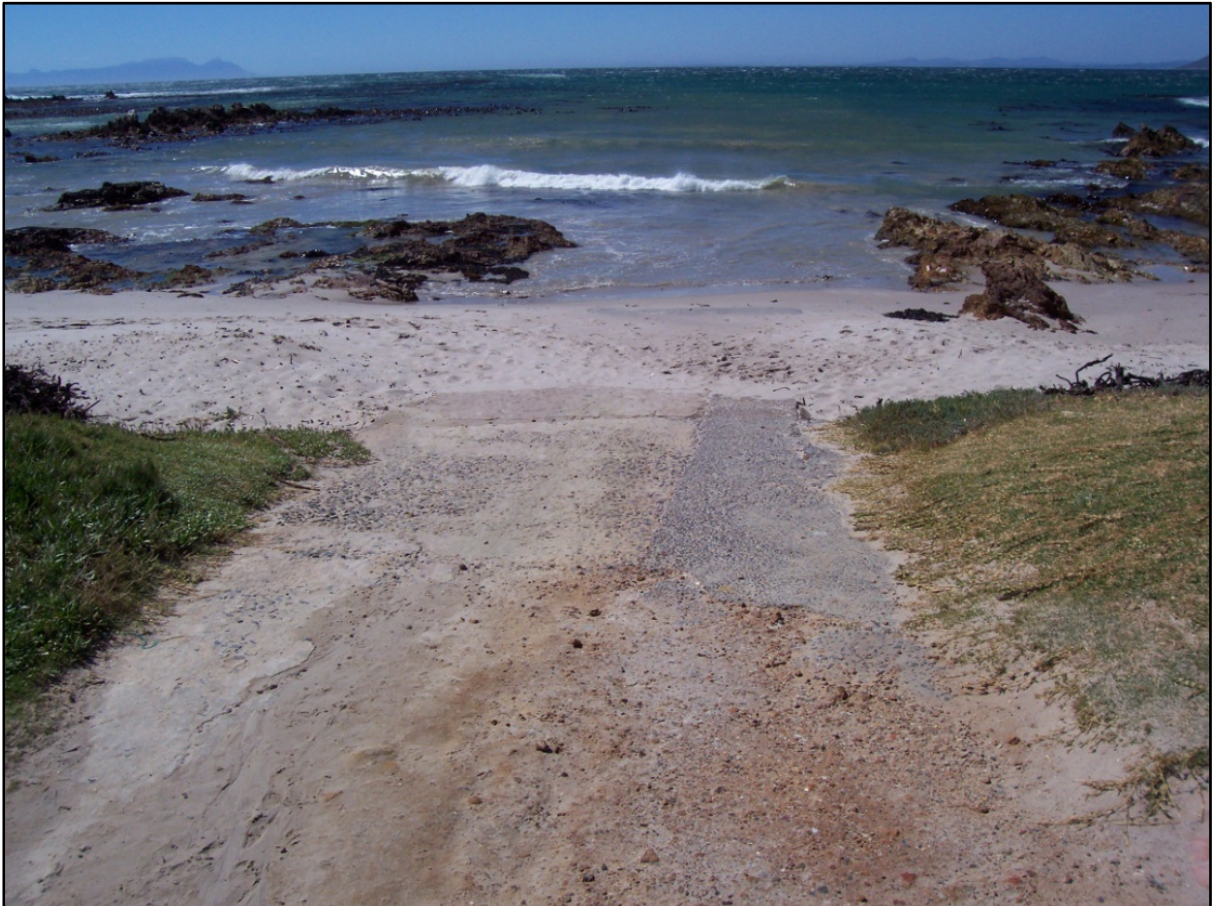
The launch is a concrete slipway which has become partially buried by sand. It is a private slipway in a fair state of repair. Shifting dunes covering the site may become an issue and if the frequency of use were to increase it may result in disturbance to breeding oystercatchers in the area. This is a very quiet launch site and is therefore not monitored properly.

Figure 1: Rooiels slipway

Ensure that the relevant signs are erected before renewing the license and conduct regular inspections requesting copies of the launch register. Set a limit for the number of boats that may be launched here per day.

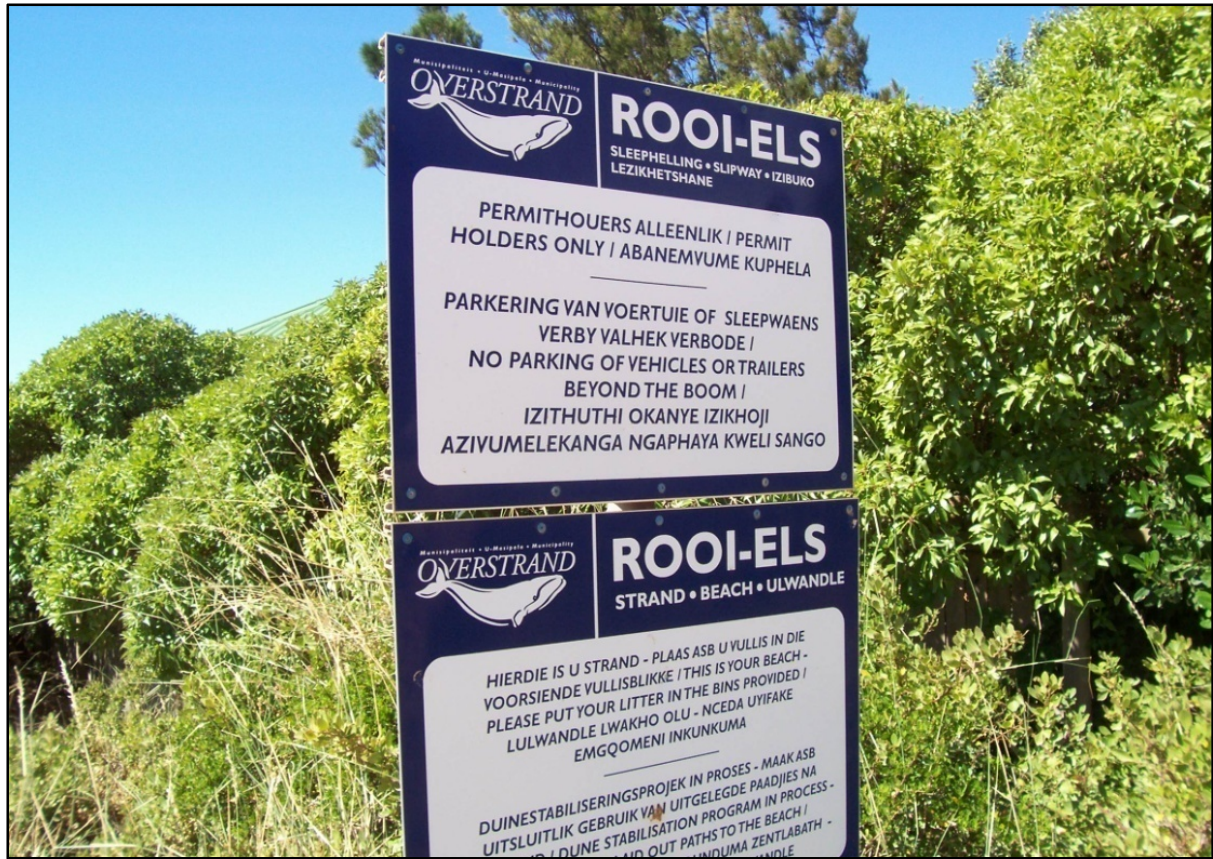
- A sign on the boom states that use is restricted to permit holders and NSRI only.

There are no details of who to contact to acquire permit for launching boats.

Figure 2: Sign at entrance to the Rooiels Boat Club Launch Site.

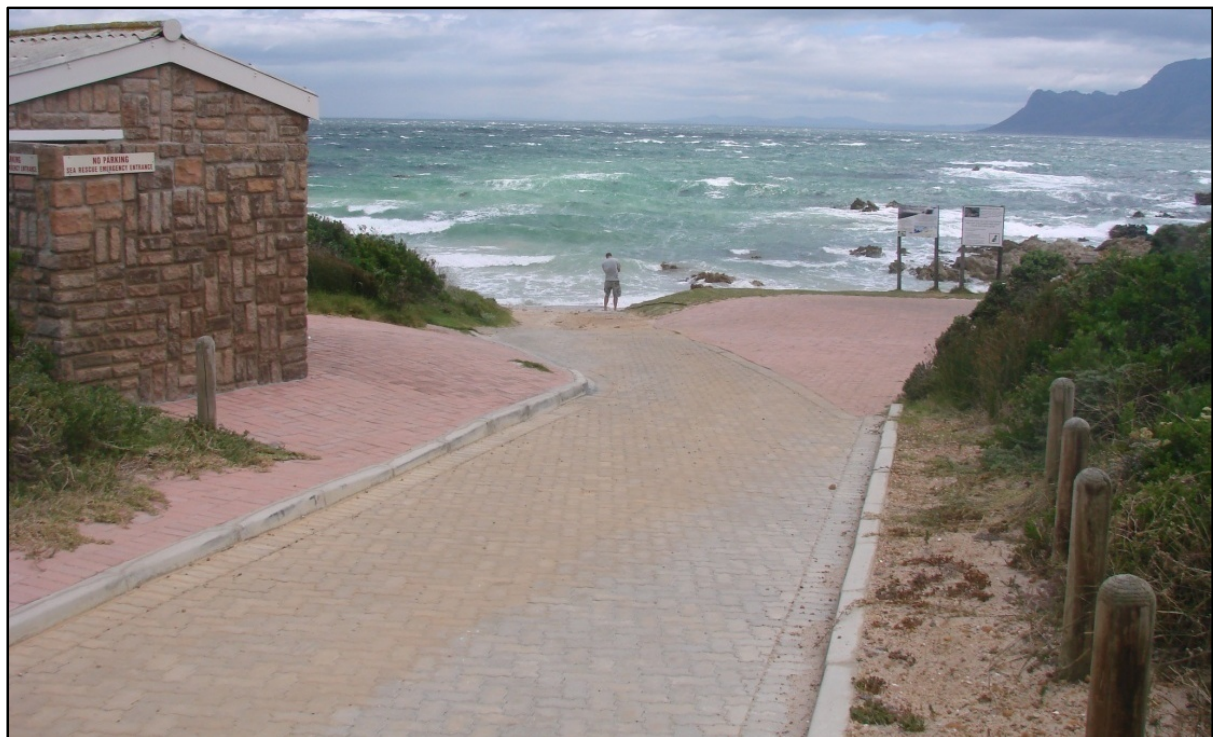
<u>FREQUENCY, EXTENT AND NATURE OF USE</u> The launch site is not used often. During summer small ski boats and rubber ducks are launched by the boat club members			
<u>NATURE OF ACCESS ROAD</u> The access road to the slipway is a mixture of gravel and concrete. There has been some growth of fynbos over the road. The road is a private road.

There is a paved parking area measuring 15m by 8m which could accommodate 5 vehicles. There is a grass clearing off the side of the road that may be used by Rooiels boat club members only to park their trailers. The parking facilities are in a good state of repair however during peak holiday season or on good weather days parking may be insufficient resulting in cars parking along the road thereby hindering traffic and disturbing road side vegetation.

Figure 3: Access road and parking area

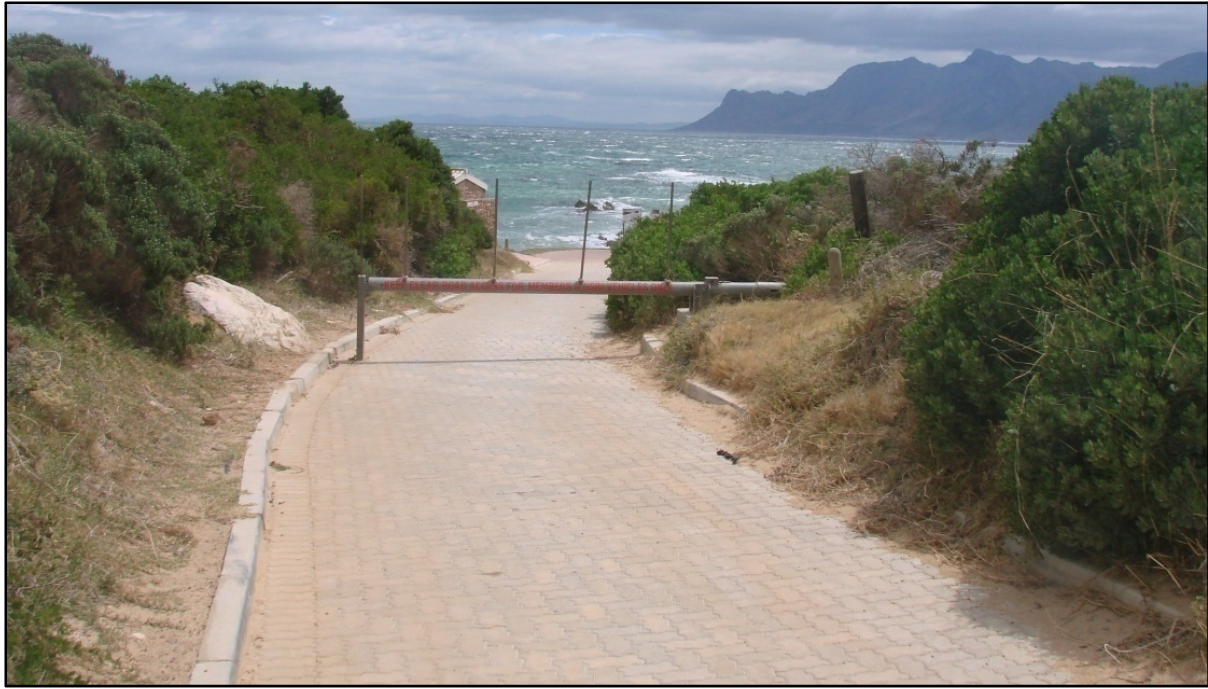
Figure 4: Boom at entrance to the Rooiels Slipway
